DAMAGE ASSESSMENT FORM

Building Name THE DAN ROBERTS HOUSE

Address 18240 S.W. 248 street (COCONUT PALM DRIVE)

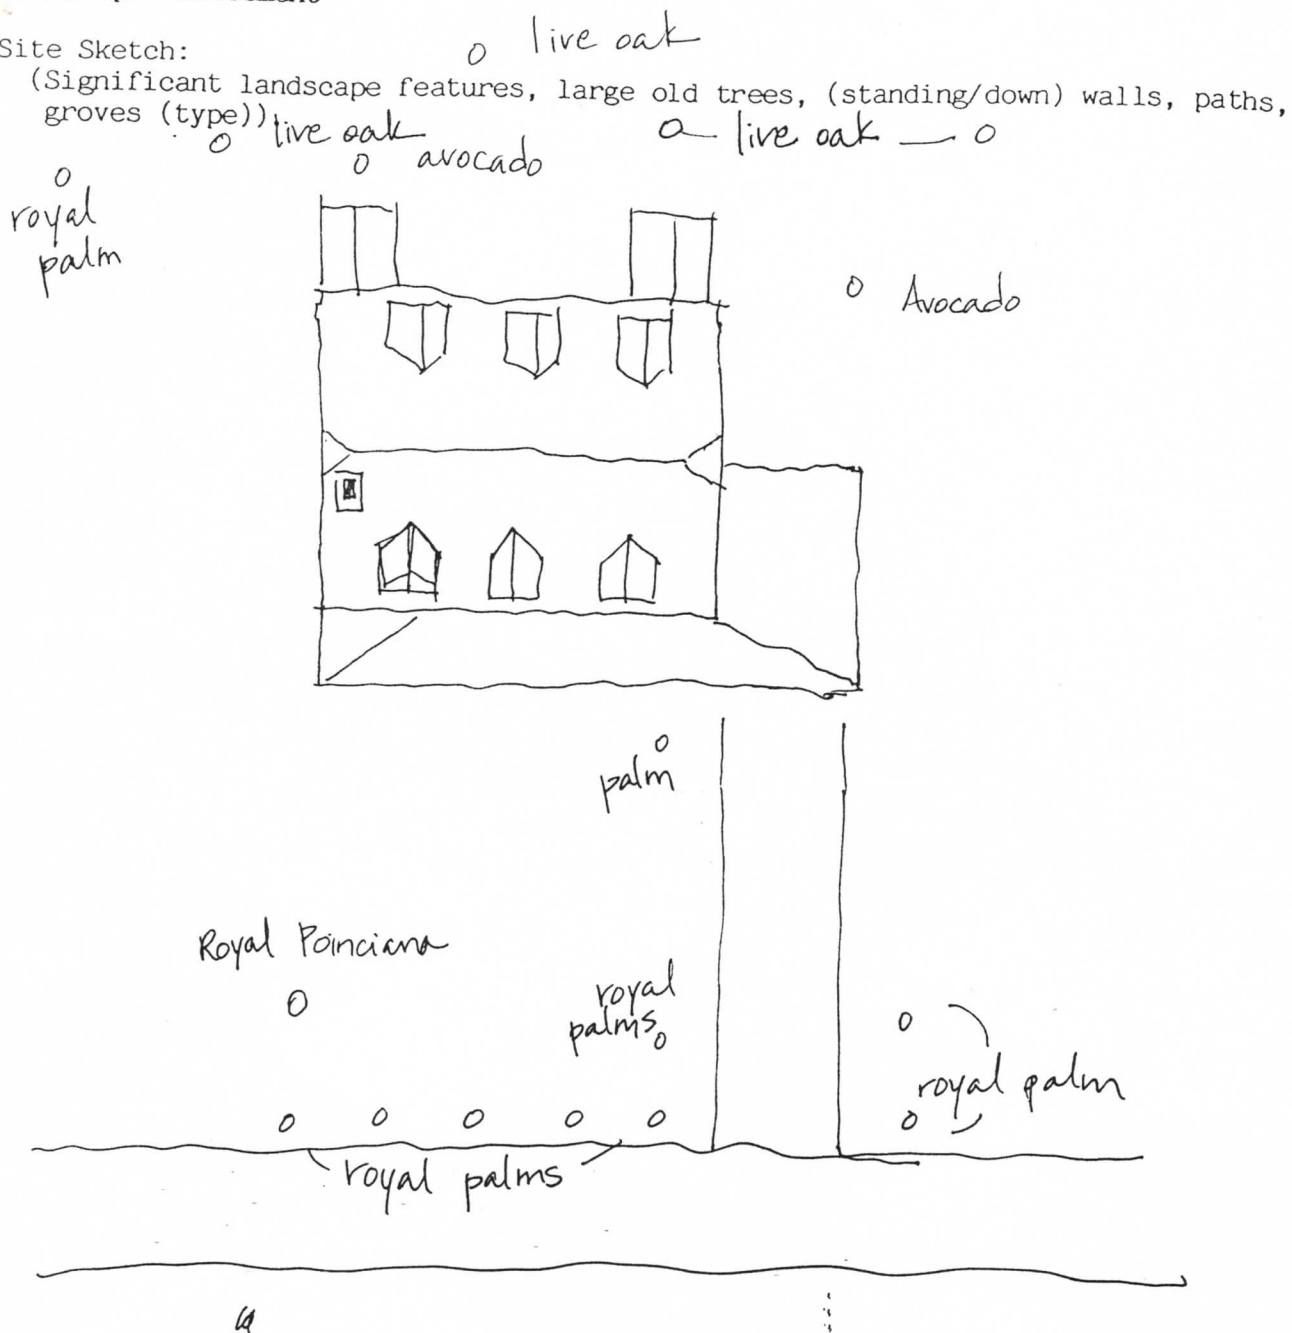
Site Sketch:

- 4 royal palms down
- avocado tree uprooted
- most trees still standing, just lost limbs
